PRELIMINARY RESULTS FROM FULL-SCALE FREE VIBRATION TESTS ON A FOUR STORY REINFORCED CONCRETE BUILDING AFTER SEISMIC REHABILITATION BY BASE ISOLATION

Keywords: base isolation, seismic rehabilitation, full-scale dynamic testing

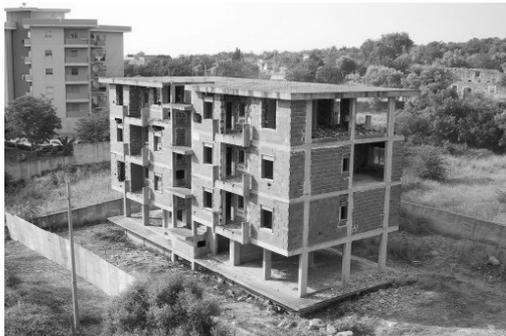
Figure 1. One of the Solarino buildings.

Two four story reinforced concrete buildings were planned in the small town of Solarino in the late seventies by the Institute for Council Houses (IACP) of the Syracuse province in Eastern Sicily, Fig. 1. The contractor abandoned the building site after the concrete skeleton and the perimeter and partition infilling walls were completed. No finishing and services were ever implemented. In 2001 IACP of Syracuse decided to complete the buildings. However the original design did not consider seismic action because at the time the area was considered of insignificant seismic hazard. Meanwhile in 1981 the Italian seismic code classified the area as of medium seismic hazard with an anchoring acceleration for the elastic design spectrum of 0.25 g. Therefore the completion of the buildings required their seismic rehabilitation.

The companion building to the one in Fig. 1 is shown in Fig. 21 in the test conditions. One HDRB fitted in the building of Fig. 21 is shown in Fig. 22 during one of the tests.

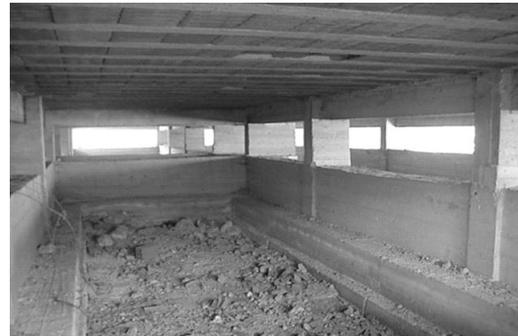
Figure 2. Partial view of foundation.

On-site inspection showed immediately favorable conditions for seismic rehabilitation by base isolation. In fact the existing foundation rests on limestone emerging from the Climiti Mountain formation and the structural system already appeared ideally suited to be easily supported for the operation of column cutting and insertion of the isolation bearings, Fig 2.

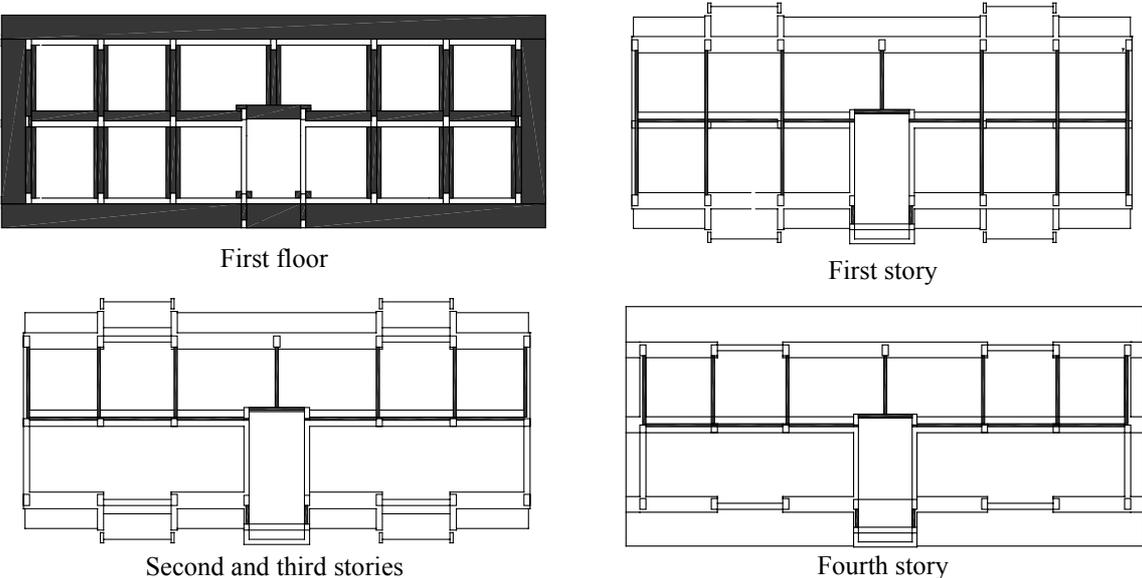
Figure 3. Strengthening of the superstructure.

Strengthening of the superstructure was required to lower its fundamental period, to enhance its seismic resistance and to limit inter-story drifts. As is shown in Fig. 3 the first floor slab was largely rebuilt to ensure a safe transmission of stress from the superstructure to the foundation through the isolation bearings.

In particular, the transverse beams were demolished and reconstructed, the cantilever slab surrounding the building was demolished and rebuilt and a portion of slab parallel to the longitudinal central beam was demolished to allocate the base for the central concrete wall. Thin concrete walls (15 cm thick) were built as shown in Fig. 3 for the complete height with

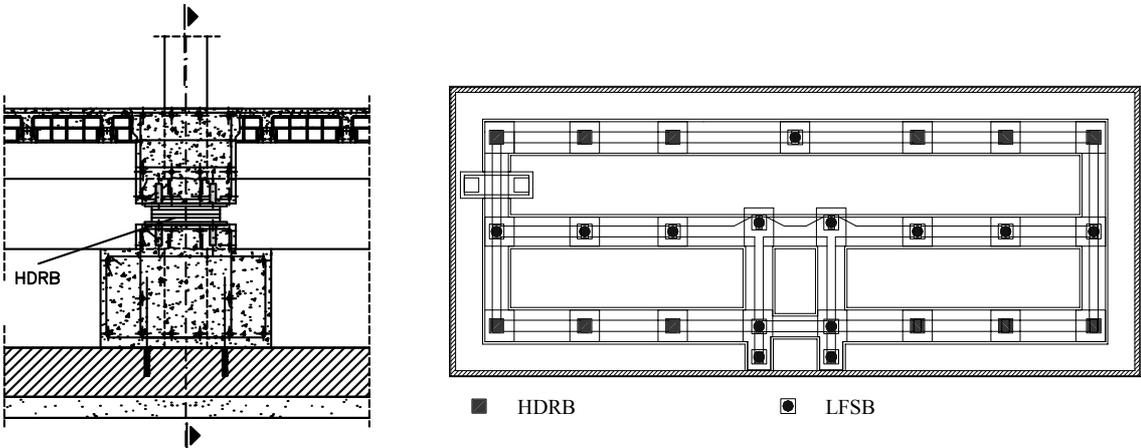
Figure 4. Foundation enlargement. Figure 5. Layout of the dual seismic isolation system.

the intention of improving the seismic resistance of the building and to limit the inter-story drifts. The original foundation was locally enlarged as shown in Fig. 4 to accommodate the isolation bearings and to allow a better stress transmission to the foundation.

A dual system of 12 High Damping Rubber Bearings (HDRB) and 13 Low Friction Sliding Bearings (LFSB) was used for base isolation as shown in Fig. 5.

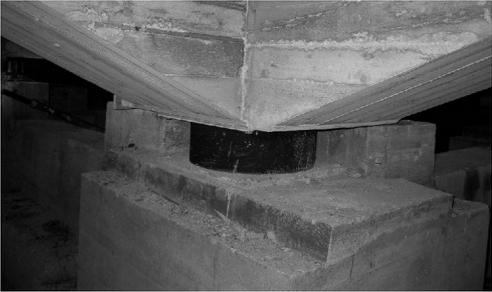
Figure 6. High Damping Rubber Bearing.

The HDRB isolators, Fig. 6, were built to design specification by FIP Industriale S.p.A. with the following characteristics: total height 169 mm, diameter 500 mm, working height 129 mm, rubber height 8×12 mm = 96 mm, steel height 3×11 mm=33 mm, end plates 2×20 mm = 40 mm, design stiffness 770 N/mm, test stiffness 790 N/mm, nominal damping ratio 10%.

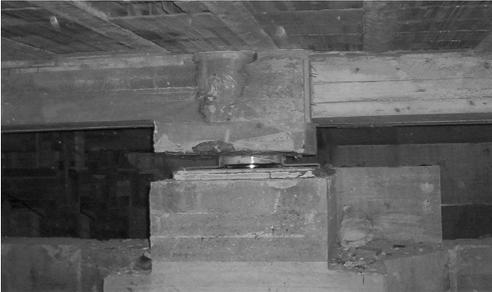
Figure 7. Low Friction Sliding Bearing.

The multidirectional VASOFLON bearing from FIP Industriale S.p.A was selected for the LFSB isolators, Fig. 7. The characteristics of the bearings used are specified by the manufacturer as follows: maximum load of 1500 kN for the 9 central bearings and maximum load of 1000 kN for the 4 lateral bearings; in both cases the maximum permissible displacement is 200 mm. Several tests performed by the manufacturer seem to indicate for the friction coefficient a static upper limit of about 2 % and a dynamic upper limit of about 1%.

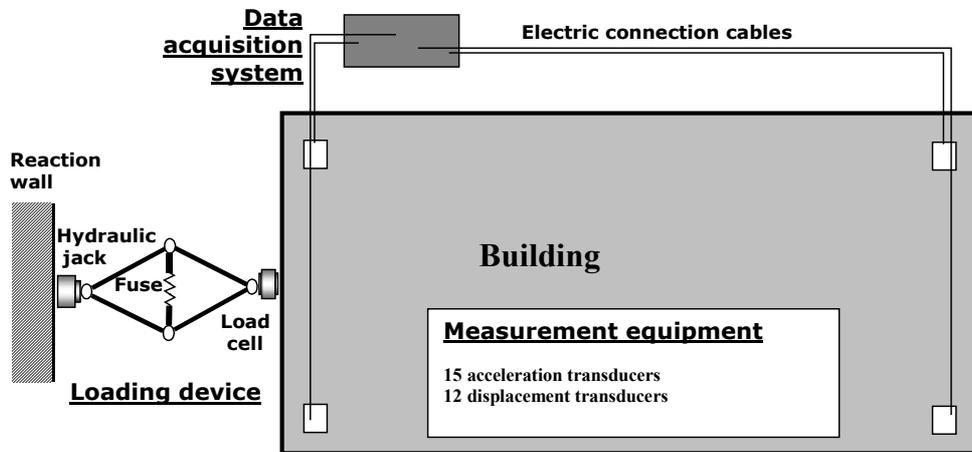
Figure 8. Testing apparatus.

The testing apparatus, Fig 8, consisted of three main items: the loading device, the measurement equipment and the data acquisition system.

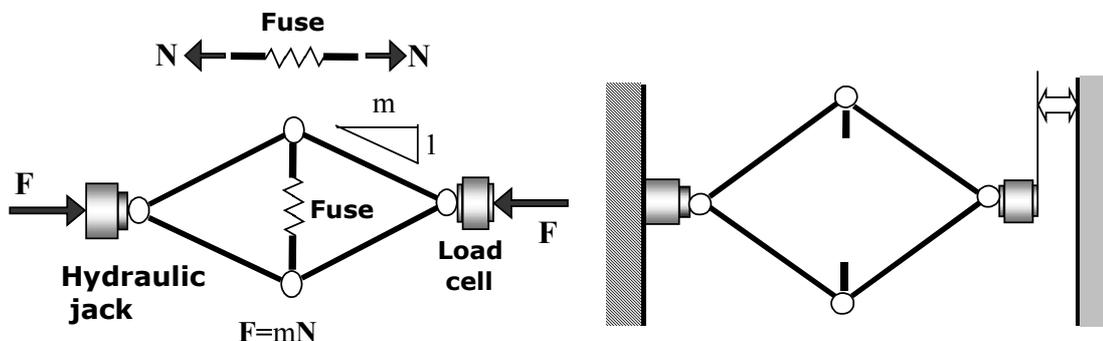
Figure 9. Sudden release device. Basic idea; F : applied load, N : traction force in the fuse.

The loading device probably is the most original part of the experiment. It consists of a reaction wall, a hydraulic jack, a sudden release device and a load cell. The sudden release device was conceived as a quadrilateral linkage with a diagonal spring preventing deformation. By dosing the rupture strength of this brittle spring, N_r , the release load F_r may be evaluated as $F_r = m \cdot N_r$, Fig 9.

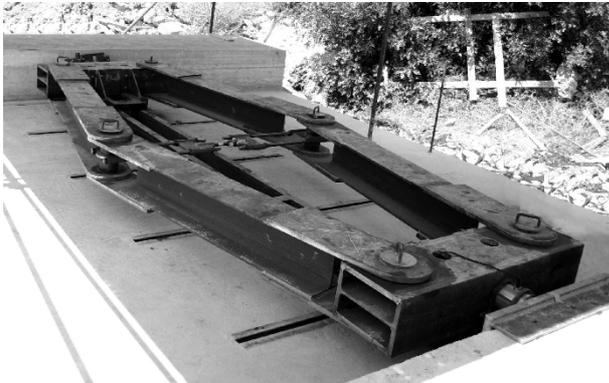
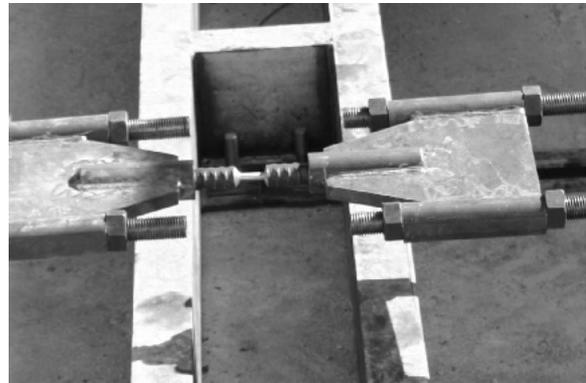
Figure 10. Sudden release device – Prototype. Figure 11. Fuse: calibrated HS steel rod.

The translation of this idea into practice resulted in the device shown in Fig. 10. The brittle spring has been constructed by means of a high strength steel bar calibrated to the right thickness so as to break under a specified load. This part of the loading device is shown in Fig. 11 and has been described as *the fuse*.

Three types of measurements have been performed: force, displacement and acceleration. The applied force has been measured by a NOVATECH mod. F205-CFR0K0 load cell applied between the building and the head of the loading device, as shown in the photographs of Fig. 10.

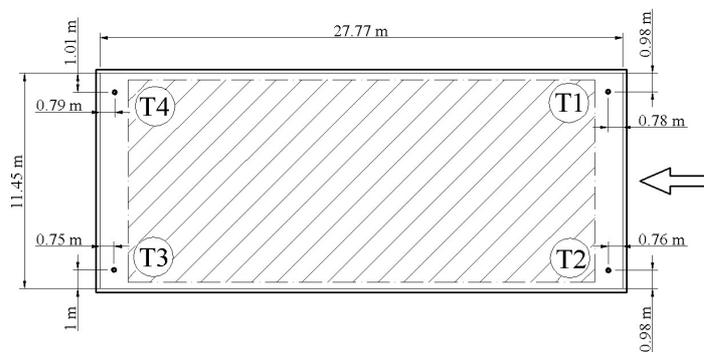
Figure 12. Location of the measuring stations.

Displacements have been measured in 4 stations at the 4 corners of the building just above the base isolation level. The measuring stations were positioned as shown in Fig. 12. Each measuring station had 3 Linear Displacement Sensors (LDS), Penny & Giles model SLS320/400 shown in the photograph of Fig. 13.

The load-displacement curve for the loading and unloading phases in the static test is shown in Fig. 16. The curve derives from the average displacement of measuring stations T3 and T4 in Fig. 12.

The time-displacement curves in three dynamic tests performed on 9 July 2004 are shown in Fig. 18. These curves were obtained from the average measurements at the four stations shown in Fig. 12. In the first test a maximum displacement of 11.48 cm was applied under a load of 1027 kN. The building completed two oscillations before coming to rest.

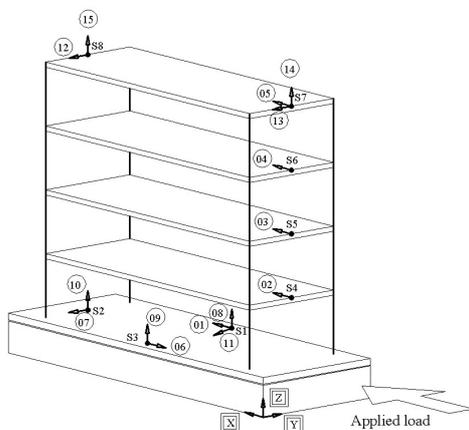
Figure 14. Schematic accelerometers layout.

Accelerations were measured by 15 seismic accelerometers, PCB PIEZOTRONICS model 393B31. The accelerometers were located as shown schematically in Fig. 14. The layout was designed so as to measure the 6 rigid body degrees of freedom and the deformation of the building along the loading direction. Three seismic accelerometers at station S7 are shown in Fig. 15.

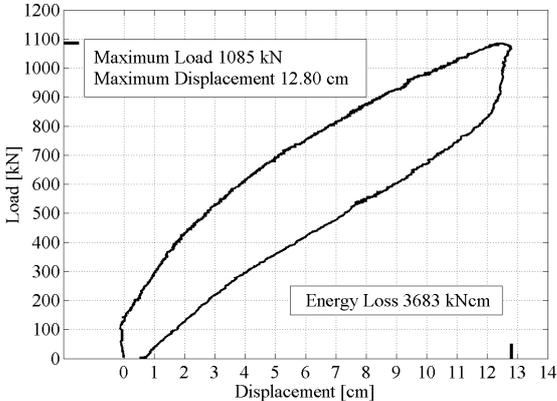
Figure 16. Load-Displacement curve (L-D).

From this curve the static friction force and the displacement dependant stiffness of the HDRB system may be evaluated. A closer view of the initial part of the loading curve and final part of the unloading curve is shown in Fig. 17. From this figure the value of the static friction force is evaluated at about 100 kN and the residual displacement upon unloading comes out at about 7 mm. The additional recovery to 5 mm at zero external load is probably due to viscous deformation of the floor slab.

The load displacement curve shows a decreasing slope (tangent stiffness) with increasing displacement amplitude. The tangent stiffness is initially infinite, due to the friction force and then varies from a maximum of 15102 kN/m when the friction force is overcome to a minimum of 4787 kN/m at maximum displacement. In the unloading phase two branches may be identified; in the first one the average stiffness is 6468 kN/m and in the second one becomes 8833 kN/m. The tangent stiffness at the end of the unloading phase (8833 kN/m) is slight lower than the design value (9240 kN/m). The low value of the tangent stiffness at the maximum displacement (4787 kN/m) may be due to the loading history where 7 long steps at constant load have been used. The average energy loss is evaluated at 3683 kNcm and accounts for viscous behavior in the rubber and for the work of the friction force.

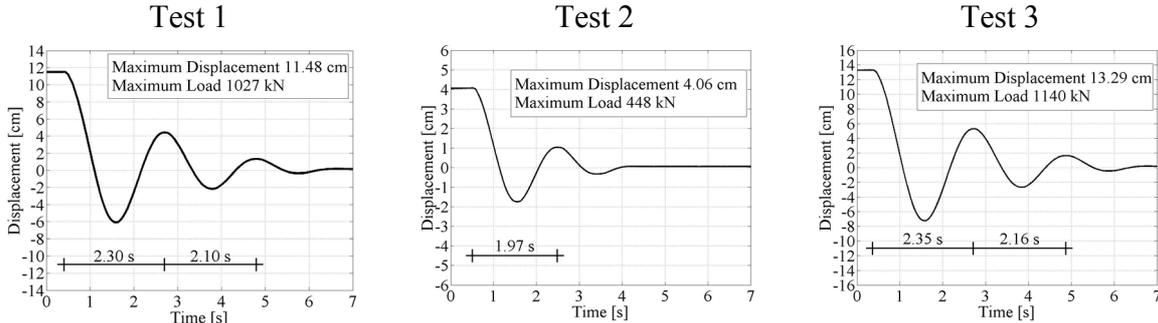
Figure 18. Displacement curves in three dynamic tests performed on 9 July 2004.

In the second test a maximum displacement of 4.06 cm was applied under a load of 448 kN. The building came to a rest after completing a cycle of oscillation. In the third test the displacement of 13.29 cm was applied under a load of 1140 kN. The building completed two oscillations before coming to rest. The residual displacement was always of the same sign and equal to 1.66 mm in the first test, 0.66 mm in the second and 1.82 mm in the third test. This is to be added to the 5mm in the static test leading to a maximum residual displacement of 8.08 mm. Unfortunately no record was kept of the trial dynamic tests performed on 8 July.

Periods of vibration have been evaluated directly from the oscillation curves of Fig. 18. A list of the evaluated periods of vibration is shown in Tab. 2 together with the maximum displacement at the beginning of the corresponding cycle. In the same table the equivalent viscous damping evaluated by the logarithmic decrement method is also shown. As expected the damped period of vibration increases with the displacement amplitude, denoting a decreasing effective stiffness with increasing displacement amplitude. Also the equivalent viscous damping decreases with displacement amplitude showing that HDRB are more effective in energy dissipation at low displacement amplitudes.

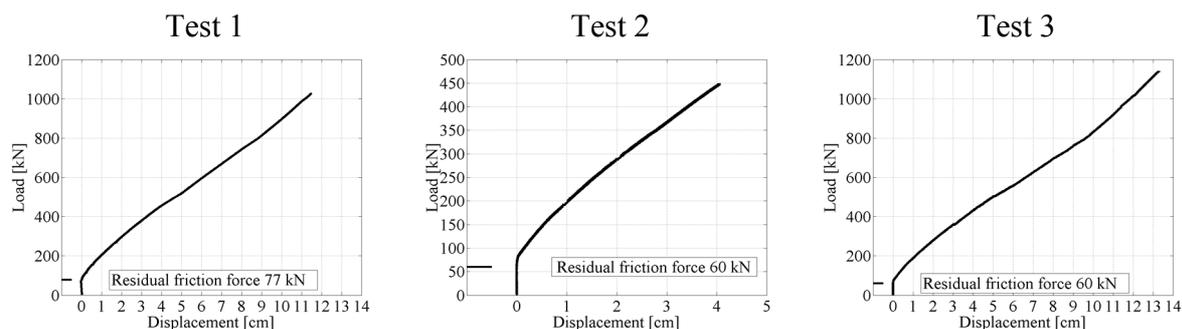
Figure 19. Load-displacement curves for the static phases of dynamic tests.

Fig. 19 shows the load displacement curves for the static phases of the dynamic tests performed on 9 July 2004. The residual friction force that must be overcome to start displacing the building can be directly measured from those curves. Other relevant information is provided by the tangent stiffness in the initial stage, middle stage and final stage of the static loading phases. The Estimated Residual Displacement (ERD) has been determined from the friction force evaluated in the static test and the initial stiffness evaluated in the dynamic tests. These results are summarized in Tab. 1.

The results in Table 1 deserve a few comments. First the measured residual friction force is always smaller in later tests than in the first test. This is due to the residual displacement and to the trapped elastic force. The initial stiffness of the system is considerably larger than the design stiffness, but it appears to diminish with successive tests. The intermediate stiffness is always smaller than the design one. The final stiffness was considerably less than the design one in the static test, but increased considerably in the dynamic tests approaching the design value from below, showing hardening of the rubber. It should be mentioned that the residual displacements have not been accounted for in the above.

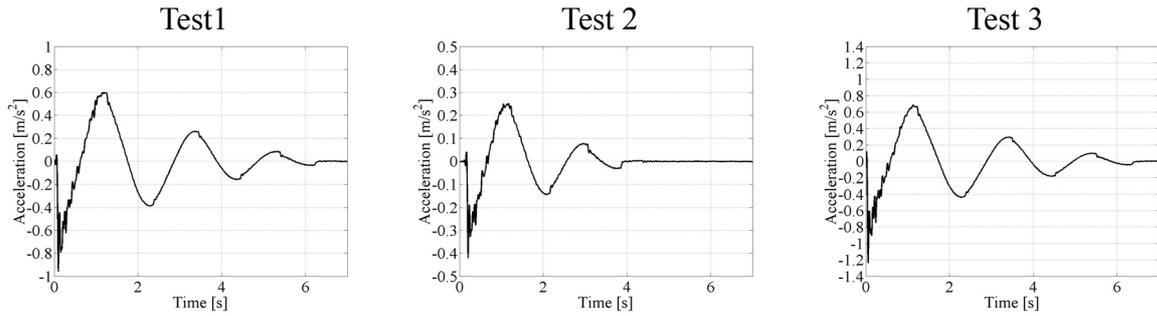
Figure 20. Accelerations measured at the height of the center of mass (Station S5 – Fig.14).

The horizontal accelerations recorded at the level of the center of mass of the building are shown in Fig. 20. The acceleration jumps due to the sign change in the dynamic friction force are clearly visible in the graphs of this figure. These jumps may be used to evaluate the dynamic friction force in the system. The results will be presented elsewhere. The peak acceleration occurs at the sudden load release transforming the pushing force into acceleration of the center of mass of the building. This allows for an estimate of the mass of the building. The peak accelerations obtained after removing the high frequency components are shown in Tab. 3 together with the estimated mass and the expected range evaluated from material weights. Individual values are within the expected range and their average (1303 kNs^2/m) compares well with the central value.
